## Test Report

**No. TR-713296311-00 (Revision 1)**

| Type of device | BGTR PRO EMC 6HE 84TE 235T; SUBR PRO EMC 6U 84HP 235D | | |
| Type designation | 19" Subrack | | |

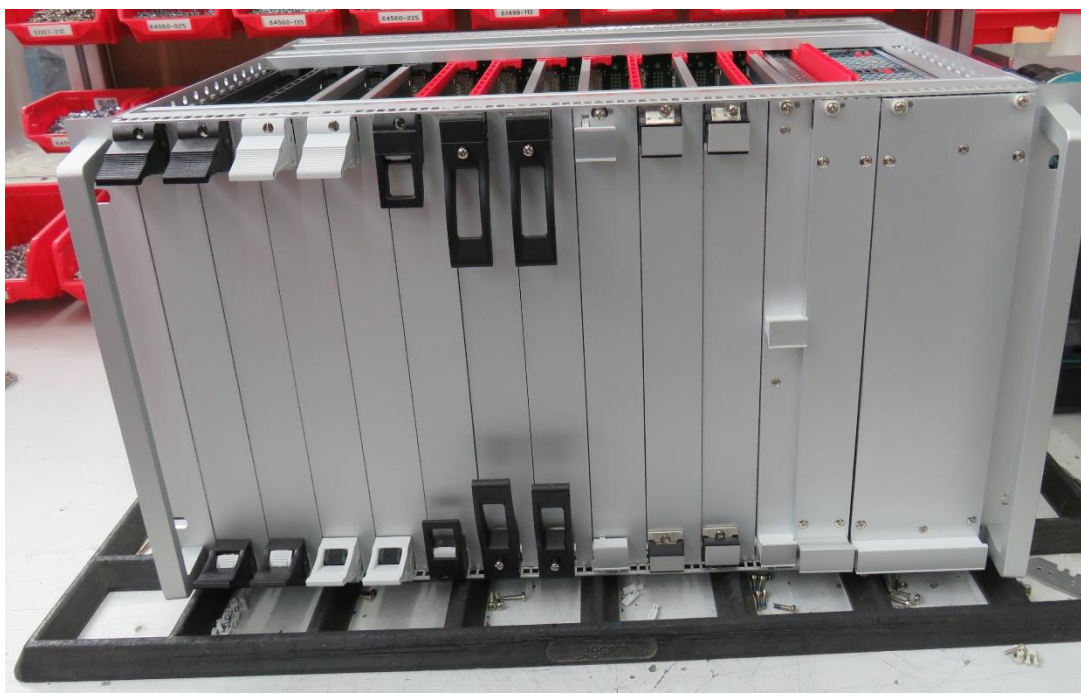
Figure 2 – DUT before test start (client picture)

| Information about the DUT | |
|---|---|
| State of the DUT at receipt: | No visible damages |

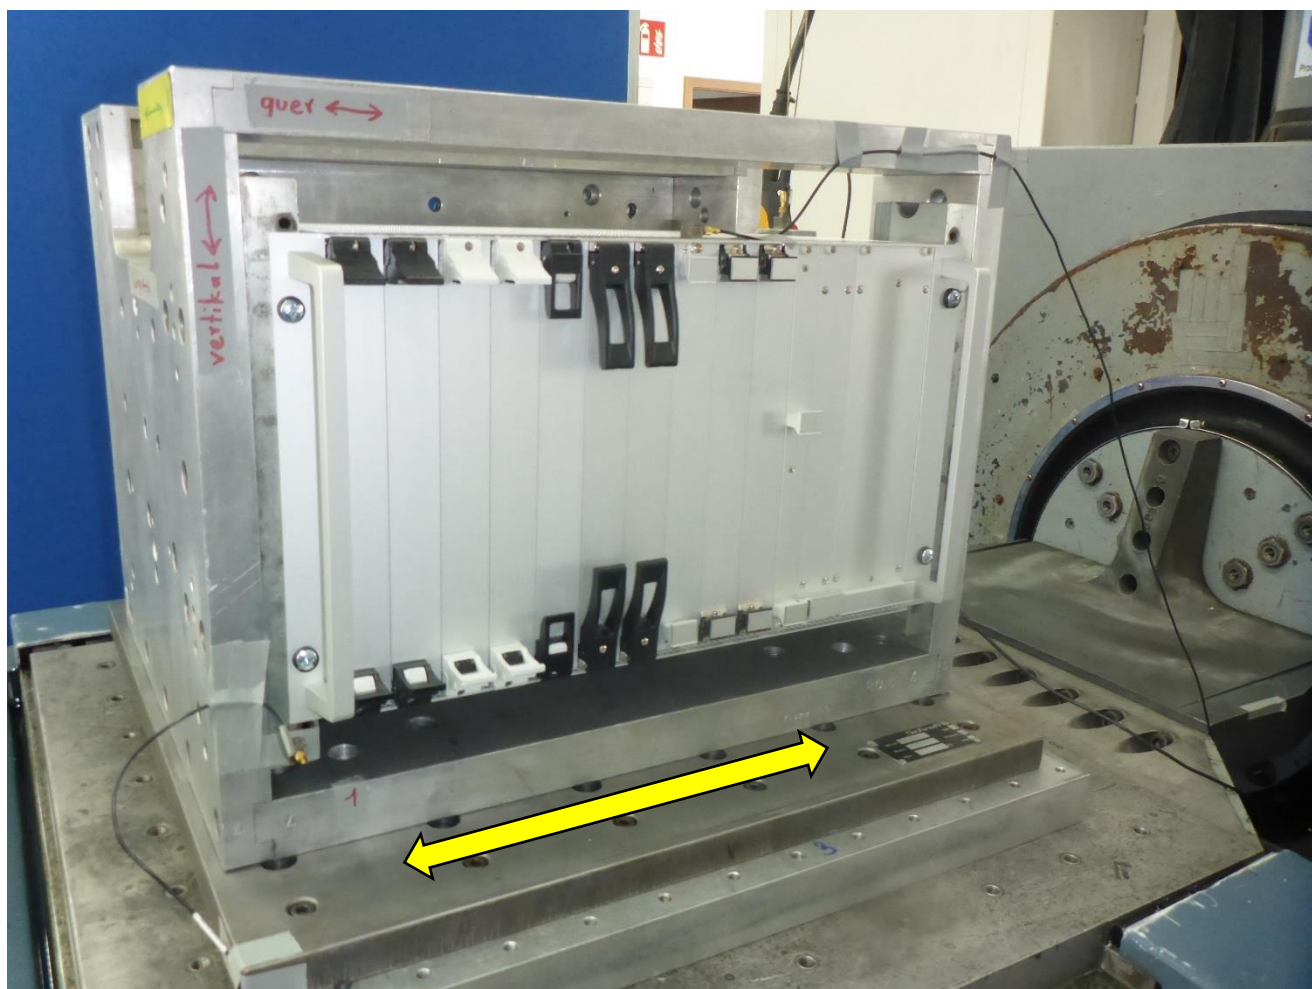
Figure 5

## Test setup crosswise-axis

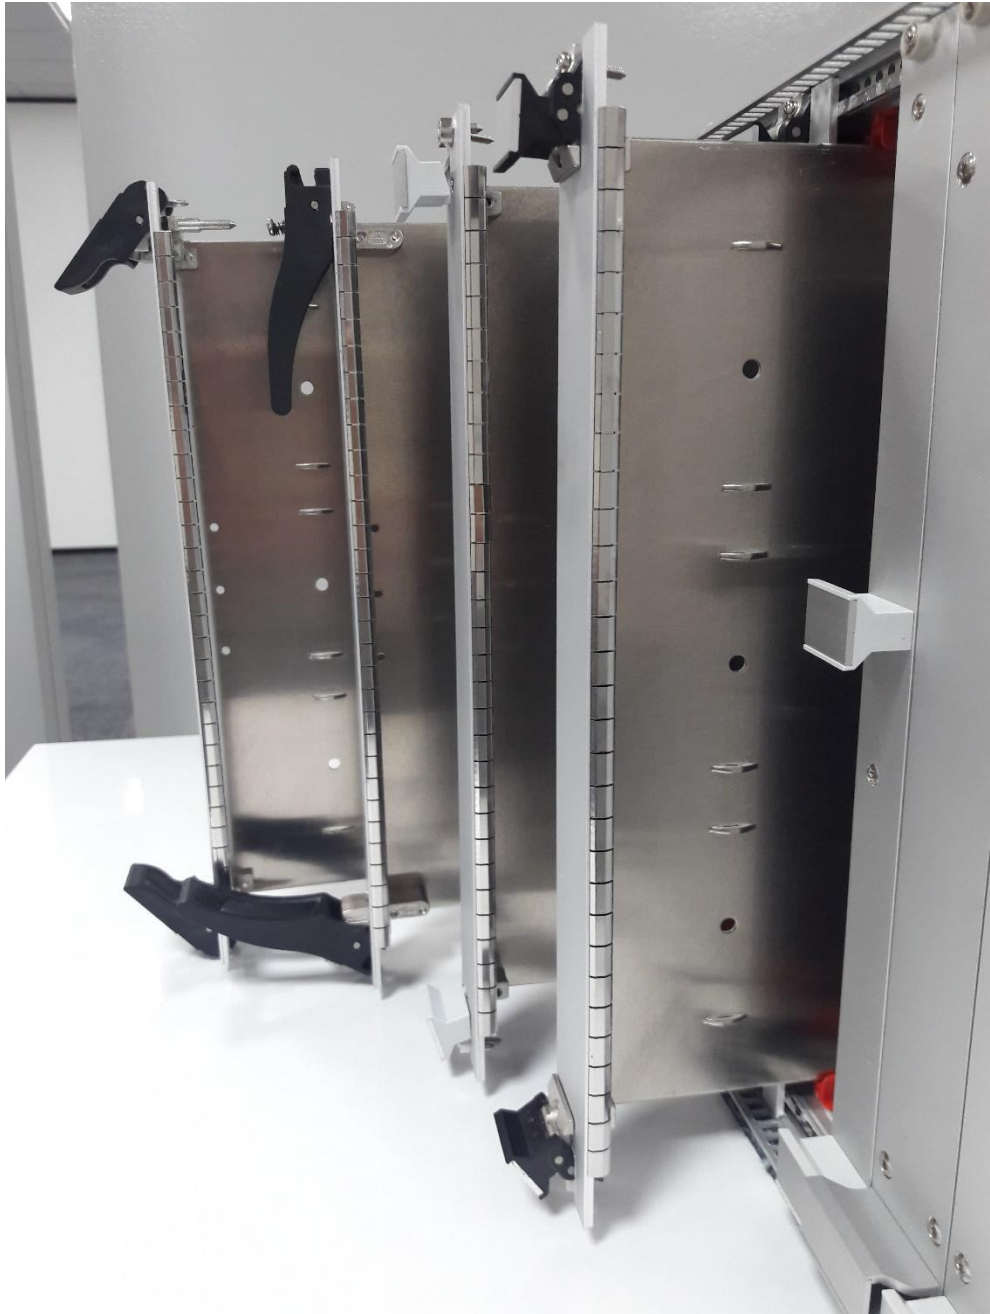
In the Schroff the internal inspection by nVent SCHROFF that followed the test, in which the subrack was dismantled again and all components were inspected by our team of experts, no complaints or anomalies were found either, tests passed.

Figure 17 – picture after test end
